TECHNICAL REPORT NO. 74-14

SCRATCH RESISTANT PLASTIC WINDOWS
FOR M151 TRUCK

March 1974

Final Report

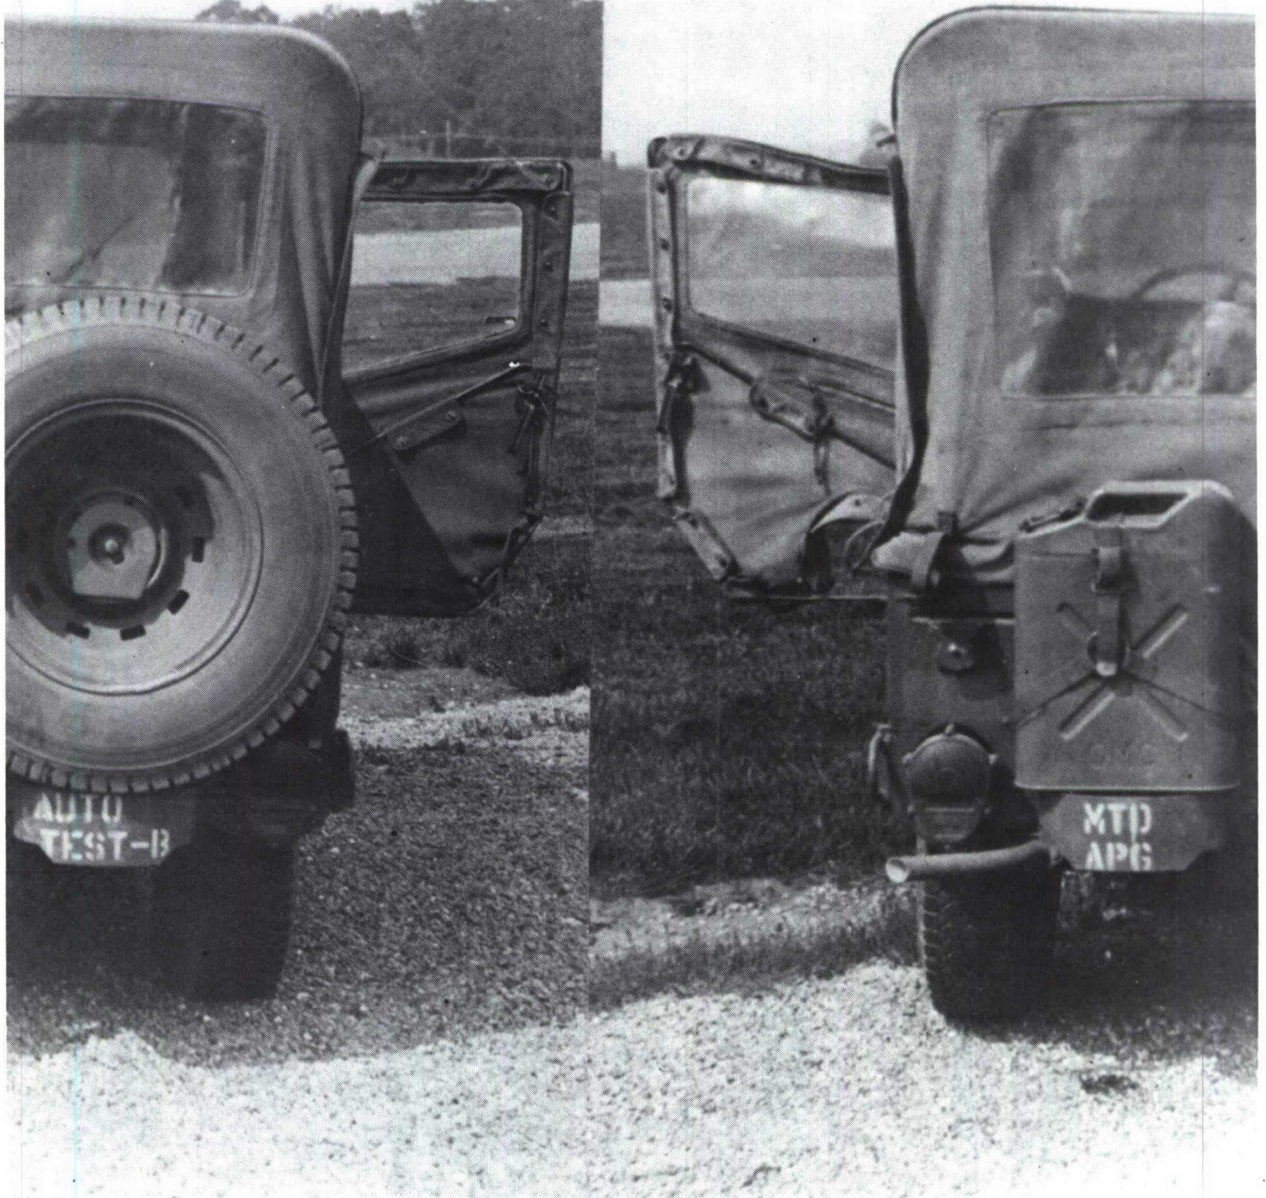
Two panels of the polycarbonate-coated plastic were mounted on an M151 at APG. The vehicle accumulated 3,937 miles during a four-month period, operating over improved and unimproved roads. The vehicle was washed an unrecorded number of times during this period. At the end of this period the windows were in good clear condition, except for a few widely separated deep scratches, as shown in Figure 4. The scratches occurred when the windows came into contact with a sharp object which exerted sufficient pressure to indent the base plastic material. There were no hazy or milky scratches which normally occur on the softer plastic material due to surface abrasion with road dirt, particularly during washing.

Figure 4. Comparison of Coated and Standard Door Windows
After Four Months of Usage and Exposure at APG, MD

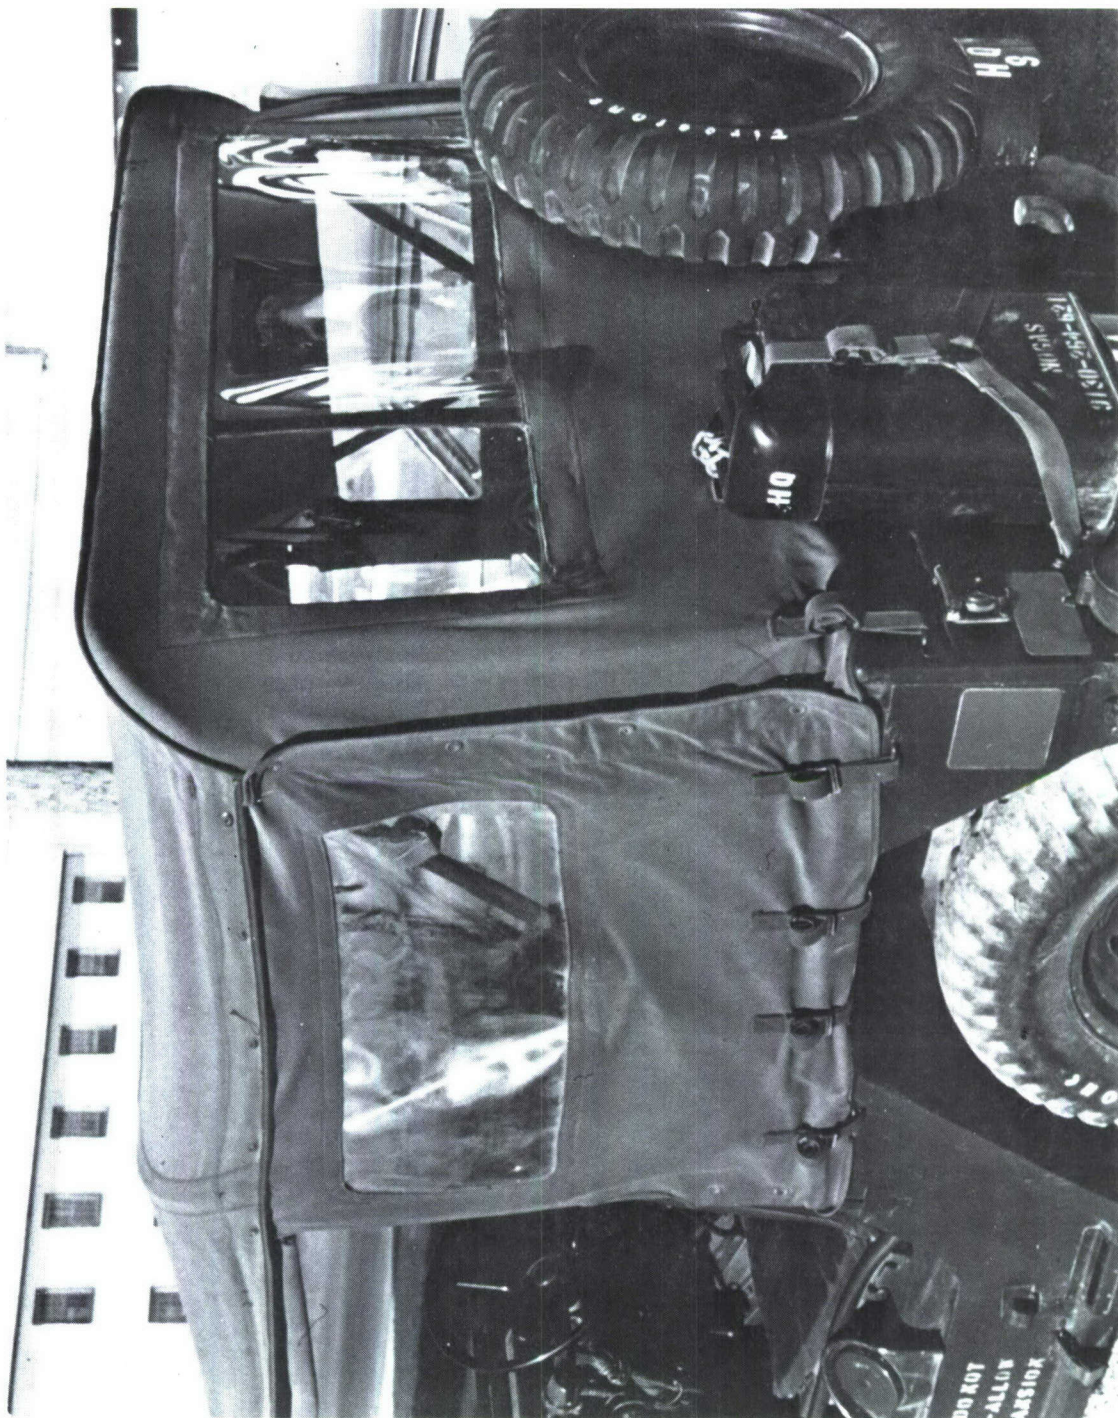
Three panels were provided to a Military Police Company at Fort Hood, Texas. These were observed for a two-month period. They were used daily, never sheltered, and washed daily. During the same period, standard panels in the same service became hazed and scratched while the test panels remained clear, as shown in Figure 5.

Figure 5. Comparison of Coated and Standard Windows After Two Months of Usage and Exposure at Fort Hood, Texas
